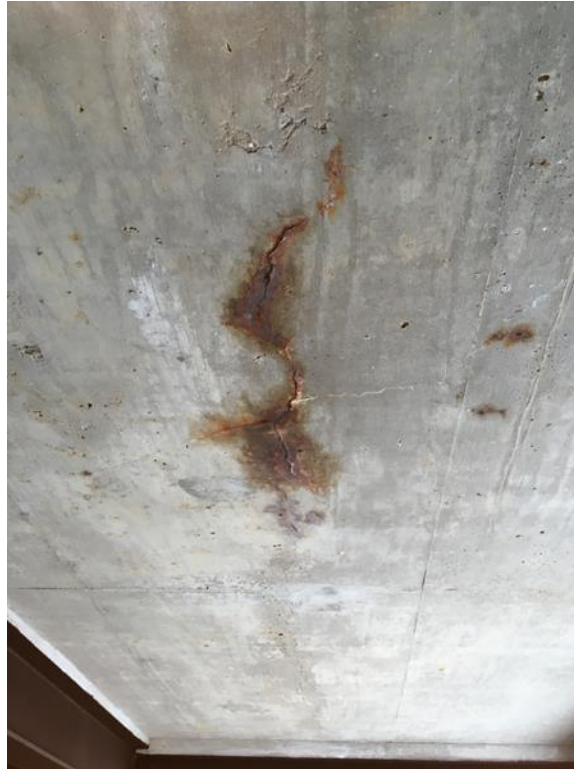
Photo 1: Distressed concrete overhead at slab.

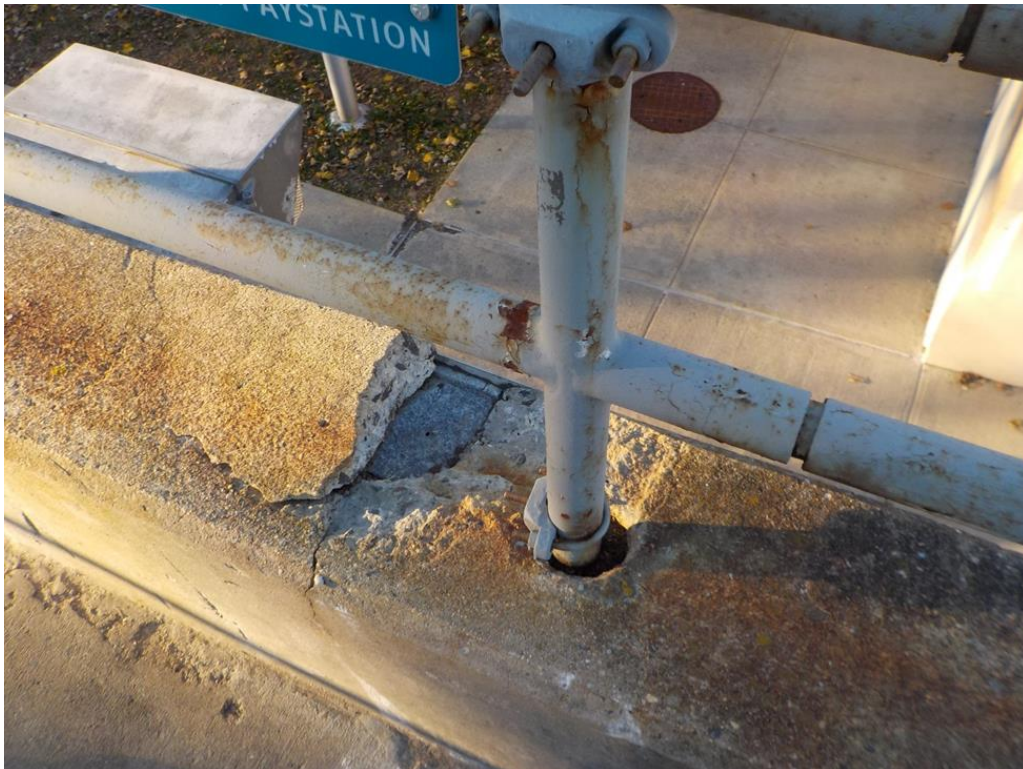
Photo 2: Loose concrete at parapet. Photo taken along north elevation.

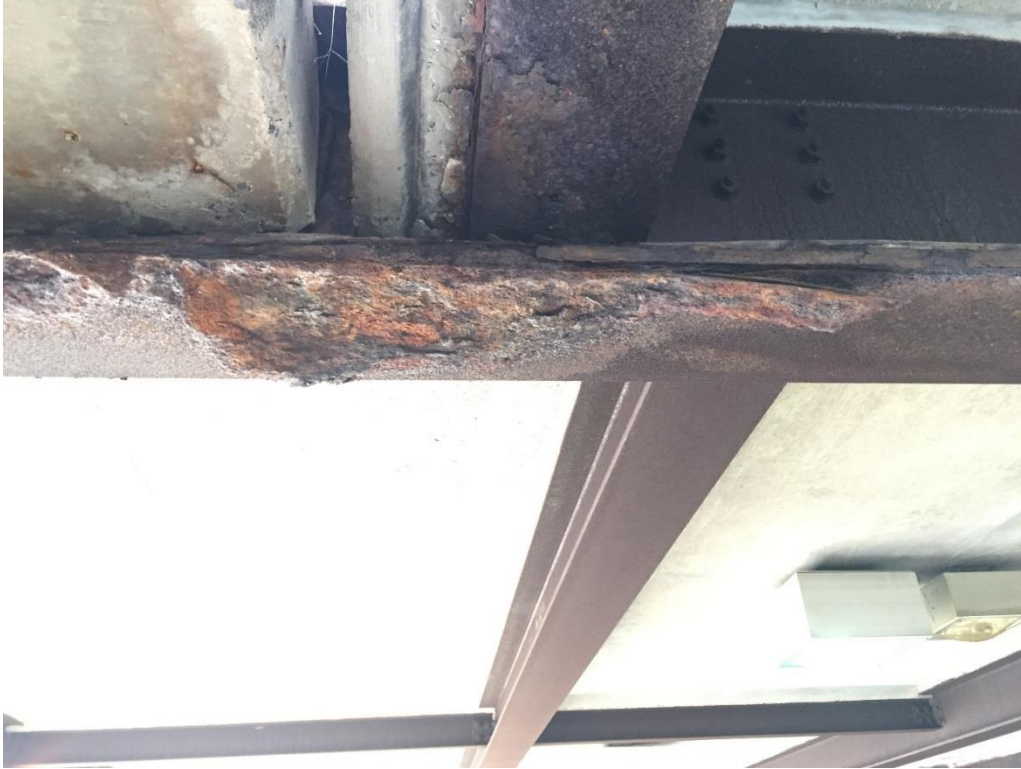
Photo 3: Loose rust at steel beam. Photo taken by south stair.

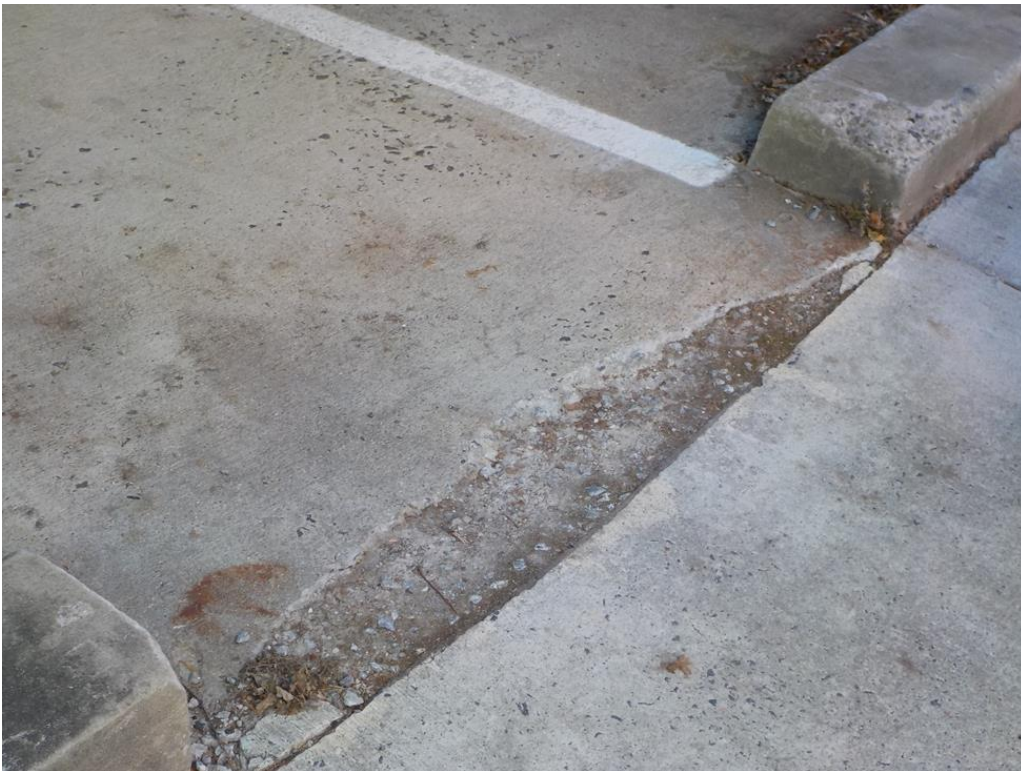
Photo 4: Spall in slab on grade. Photo taken at north elevation pedestrian entrance.

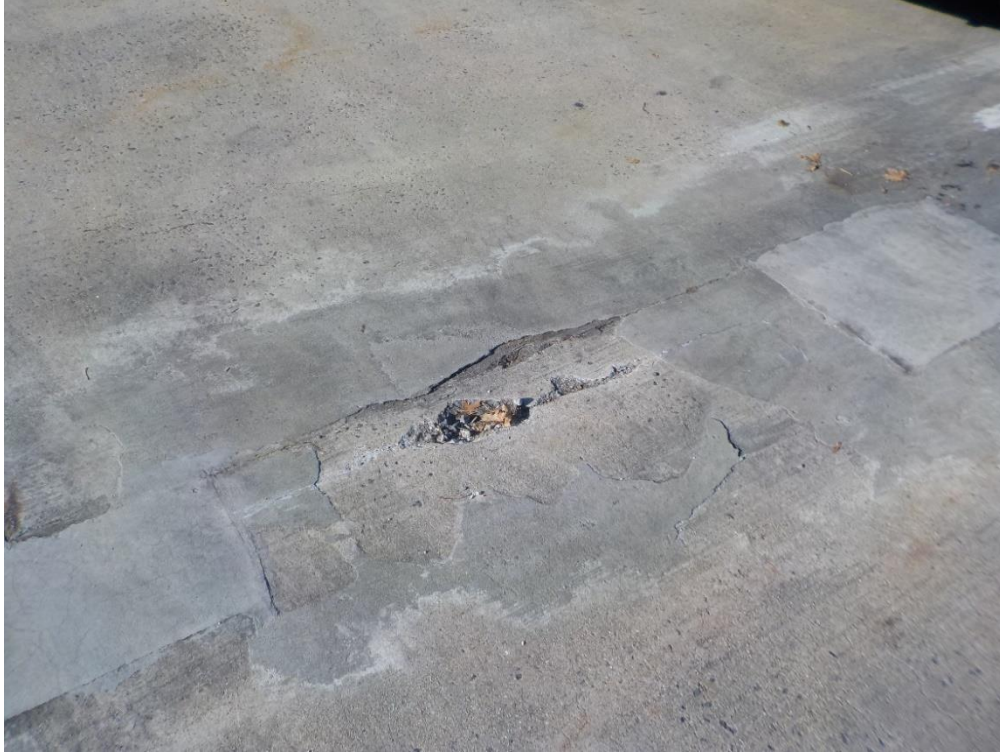
Photo 5: Spall at topside of slab. Photo taken south of the expansion joint.

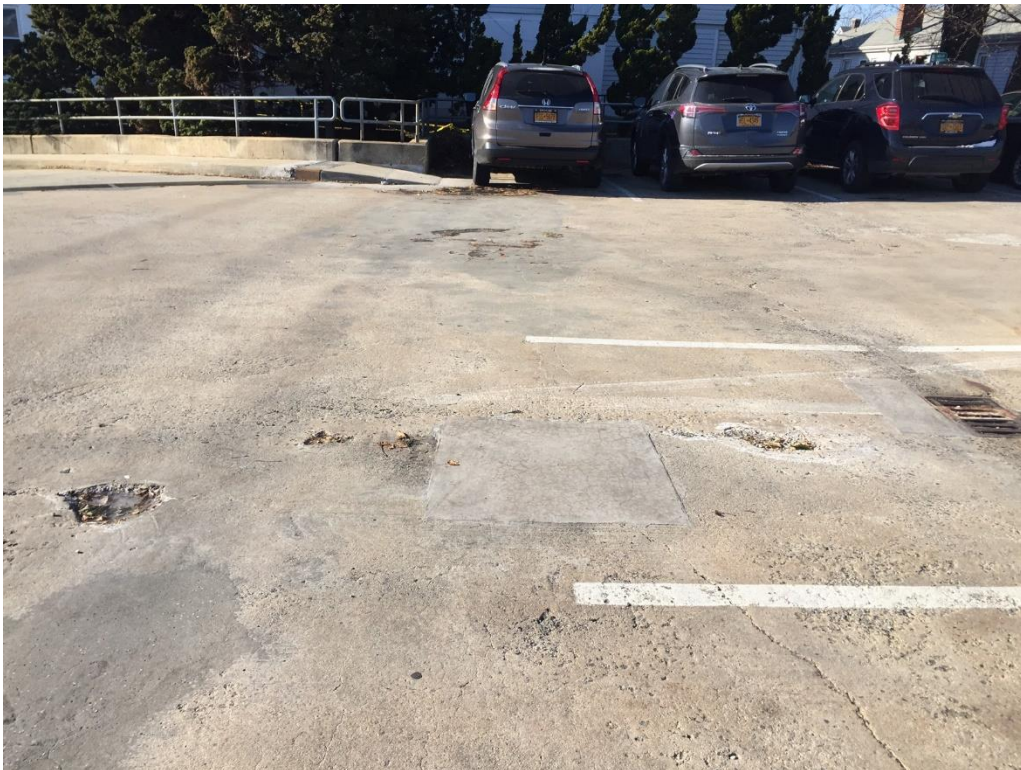
Photo 6: Spalls, concrete scaling, cracks, and ponded water at topside of slab. Photo taken south of the expansion joint.

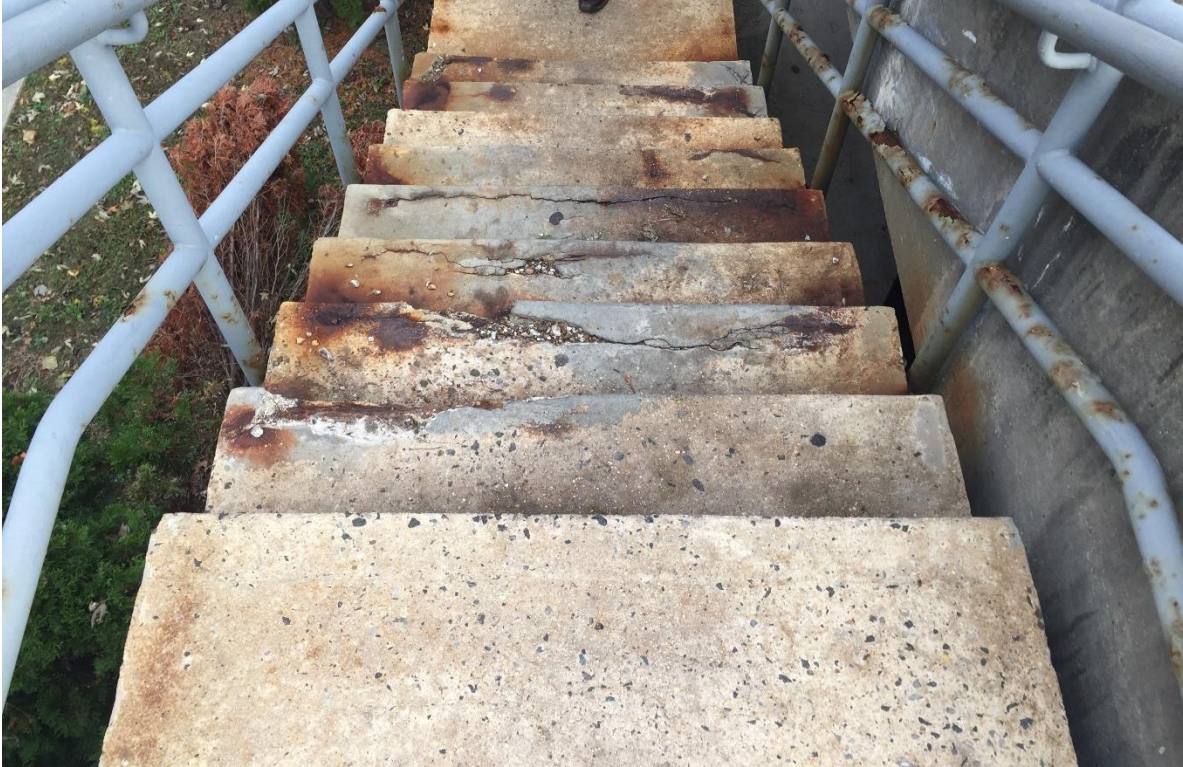
Photo 7: Spalls and cracks in stairs. Photo taken at north stair.

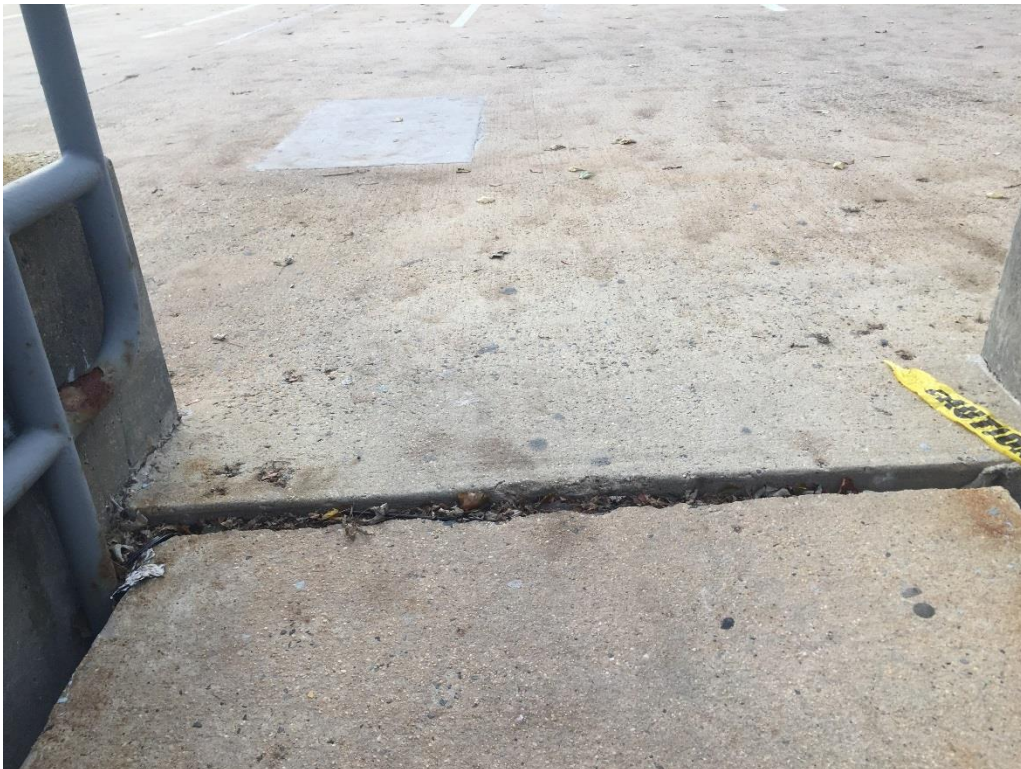
Photo 8: Gap between north stair and slab.

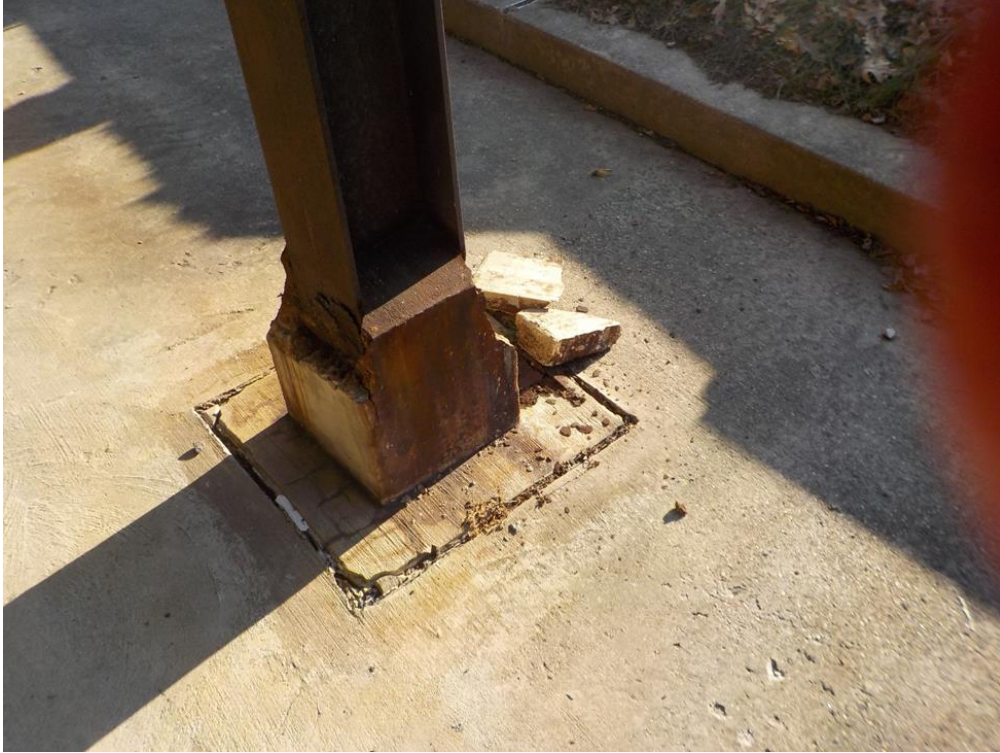
Photo 9: Spalled concrete column encasement with fallen loose concrete. Photo taken at column along south elevation.

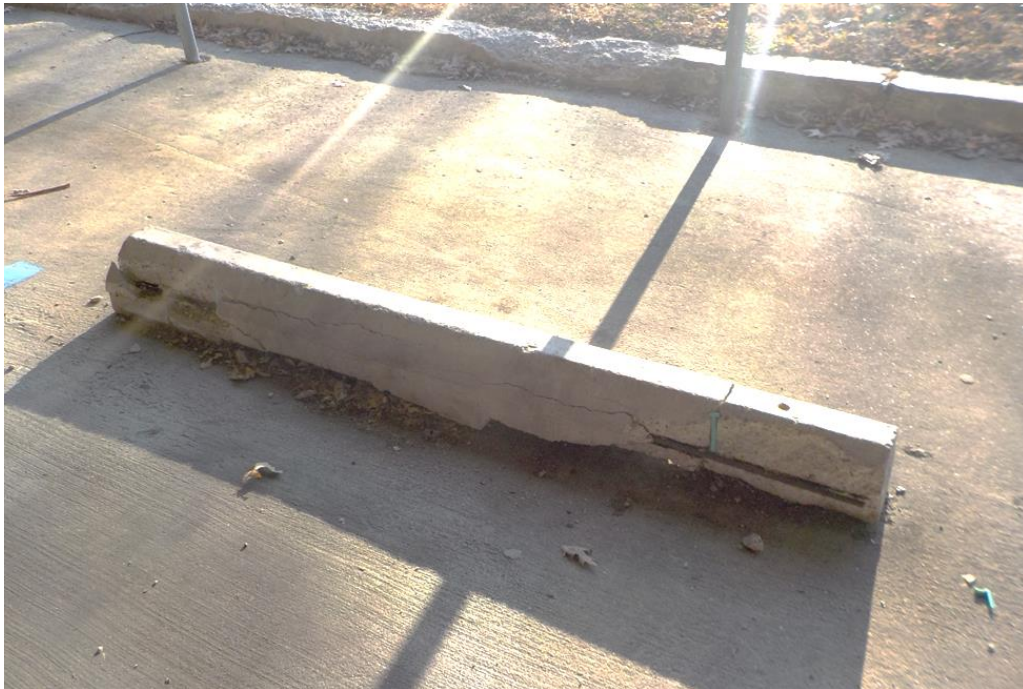
Photo 10: Spalled concrete wheel stop along south elevation.

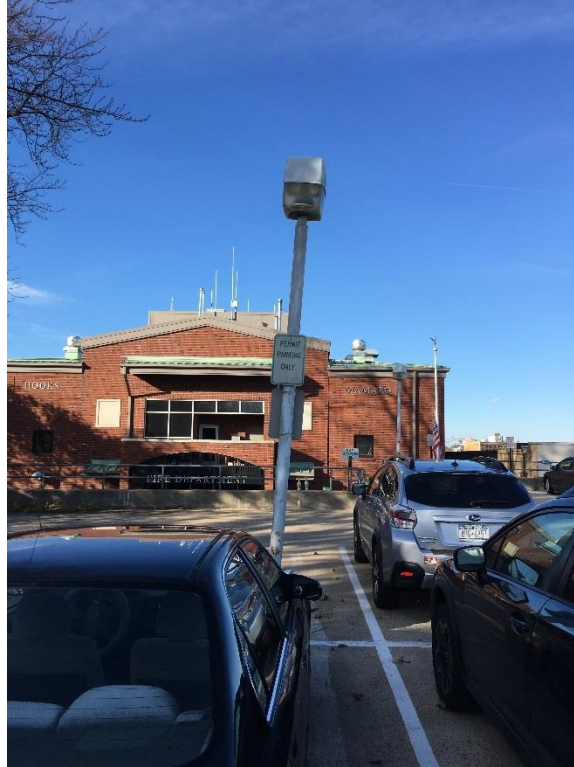
Photo 11: Unstable light post at top parking deck.

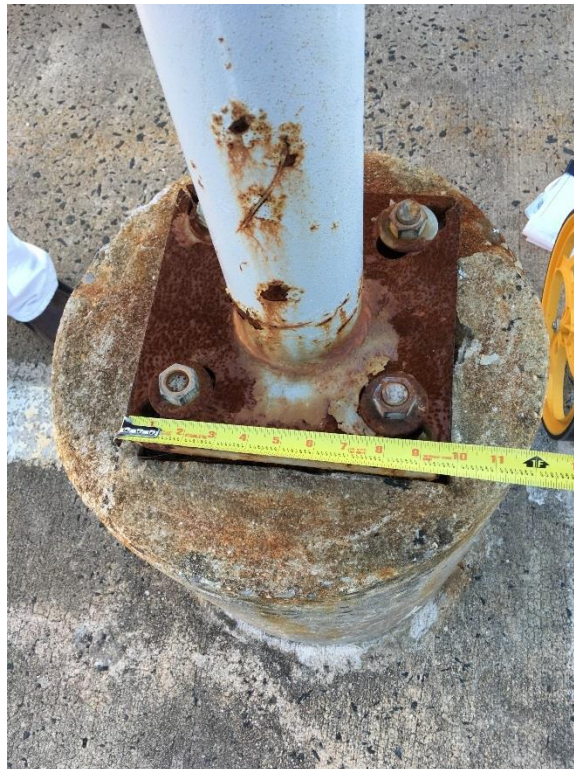
Photo 12: Corroded bolts. Photo taken at top parking deck light post.

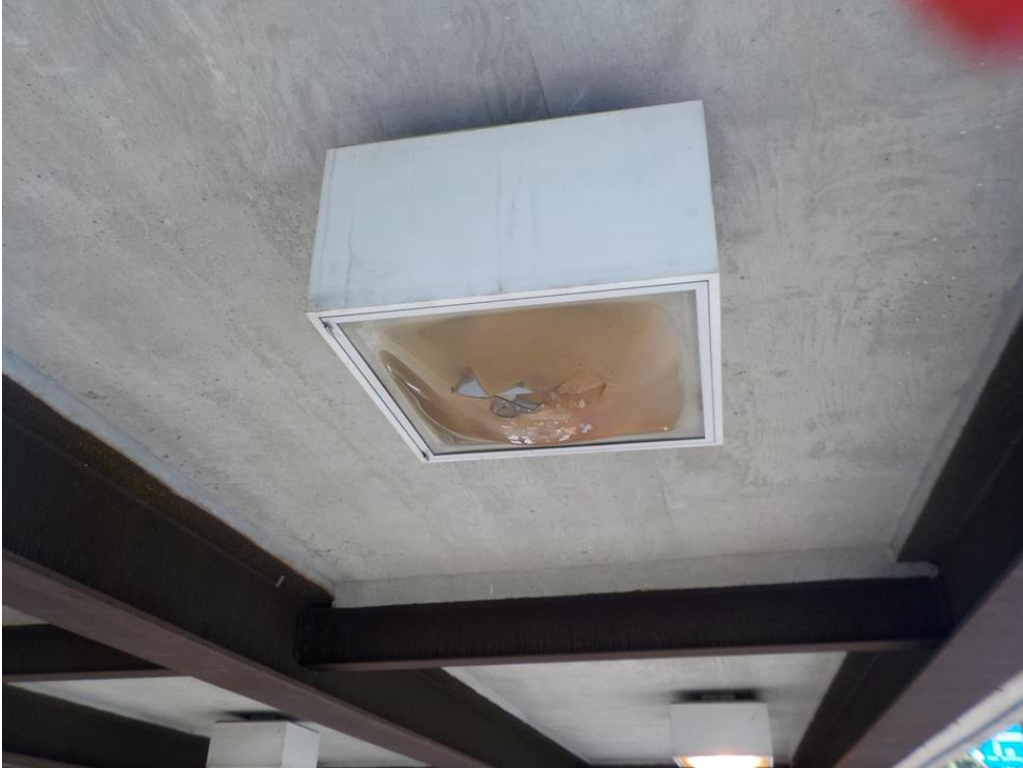
Photo 13: Cracked overhead light mounted to underside of slab.

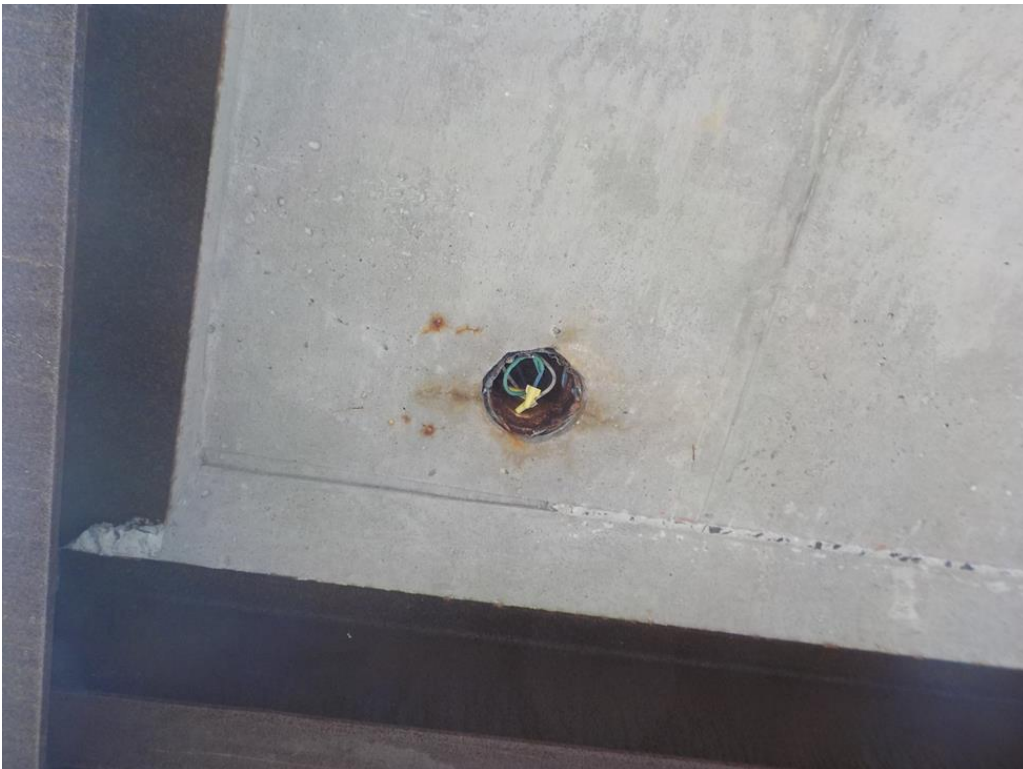
Photo 14: Exposed overhead electrical box.

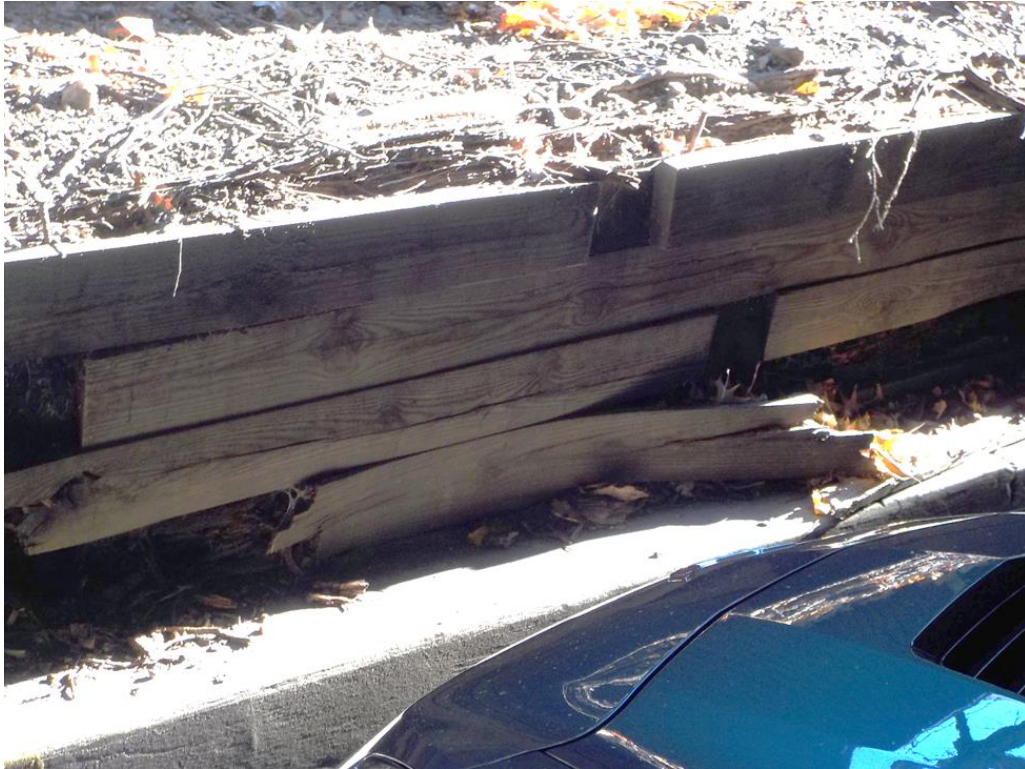
Photo 15: Deteriorated timber-tie wall along east elevation.

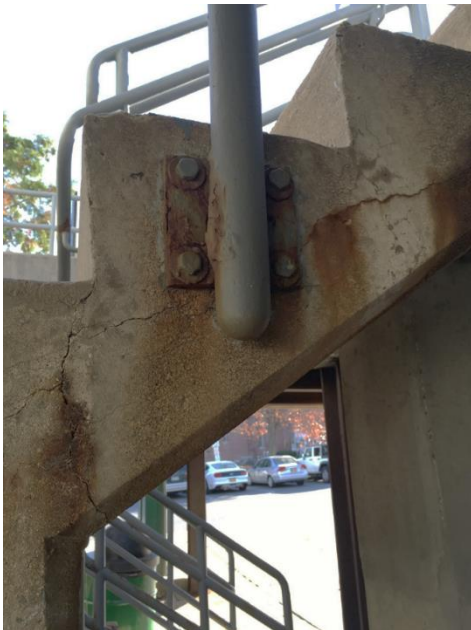
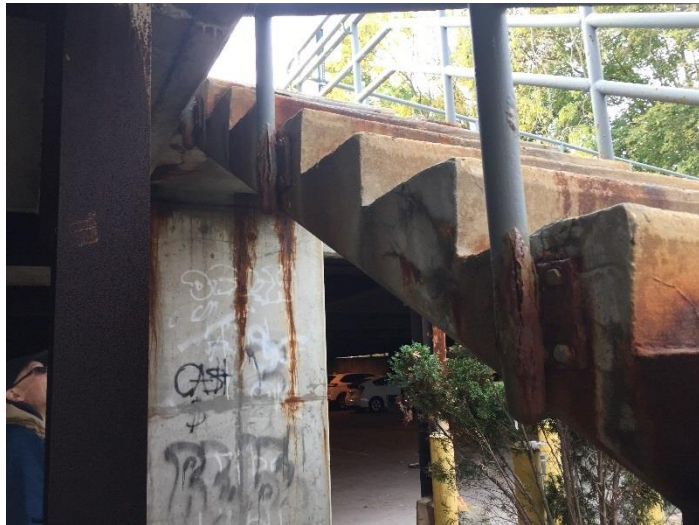
Photo 16: Corroded rail post connections anchored to distressed concrete. (L) south stair, (R) north stair.

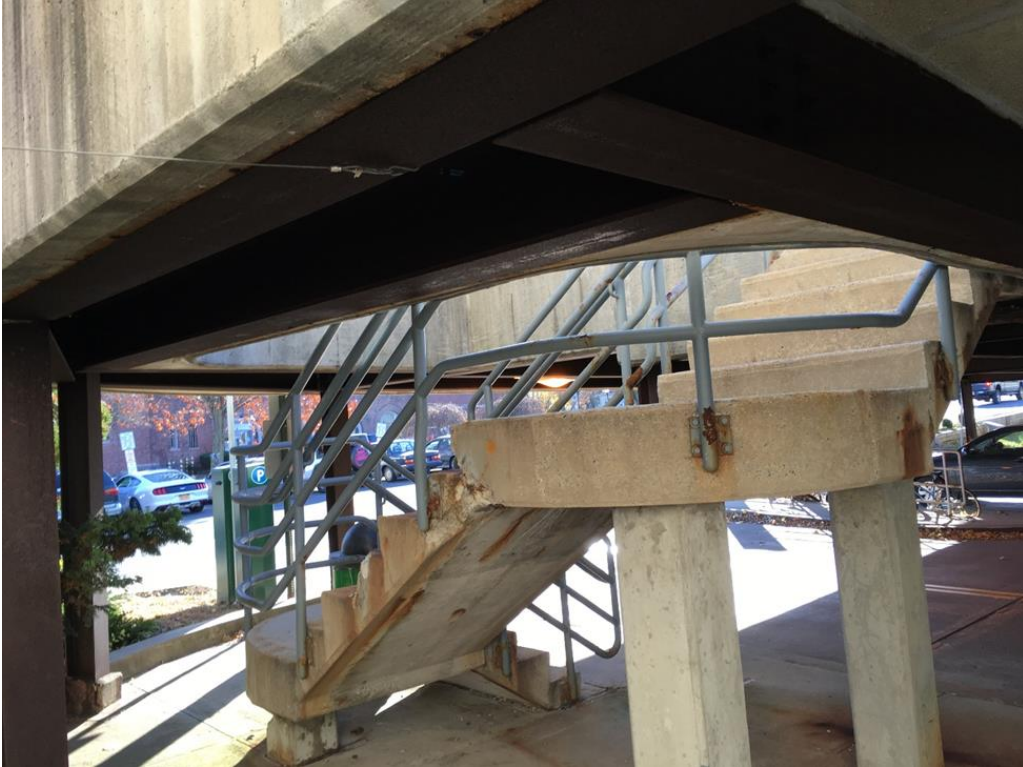
Photo 17: Gaps at stair railing greater than 4". Photo taken at south stair.

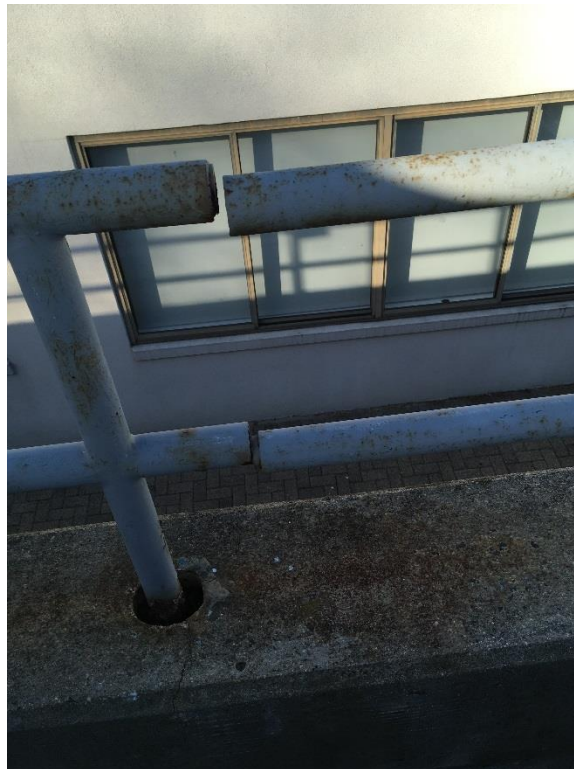
Photo 18: Deteriorated rail connection. Photo taken along north elevation.
