<u>Drain Pipe Investigation Report</u> 11/03/2020

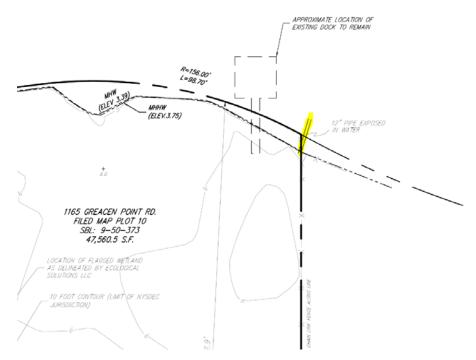
The condition of the pipe was poor with visible separation in joints in turn the line was filled with silt and unpassable with the inspection camera even after attempting to clean the line with a snake. It is our assumption that the entire length of the pipe is filled with sediment and silt and currently does not function. Since the pipe was plugged solid and unable to be snaked, we were unable determine its origins. Since the pipe is right on the property corner it should be noted that it may not even originate from the applicants property. It is unlikely that it is somehow connected to the existing septic system an no drainage structures have been identified on the project site.

Under the proposed application this pipe shall remain in place, there are no connections to it or an attempt to reuse it. To remove it would cause unnecessary disturbance within the regulated area.
