Wetland Assessment

Subject: Hampshire Country Club
Mamaroneck, Westchester County, New York

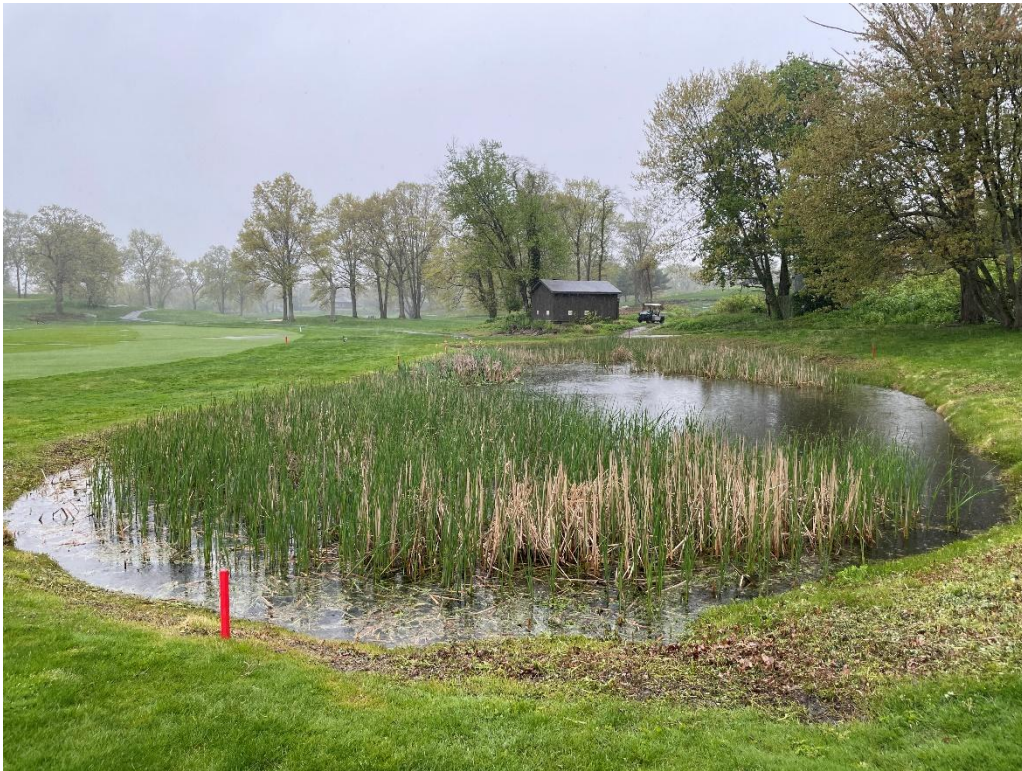
View from the northeast end. Cattails visible in portions of the feature. Pump house in background.

As a manmade feature designed for pumped groundwater storage, it is recommended that this feature be maintained so that it can continue to be used for its intended purpose. Further, without the proposed maintenance, the continued accumulation of organic matter and other sediment as well as the dense growth of aquatic vegetation may provide ideal breeding habitat for mosquitos.

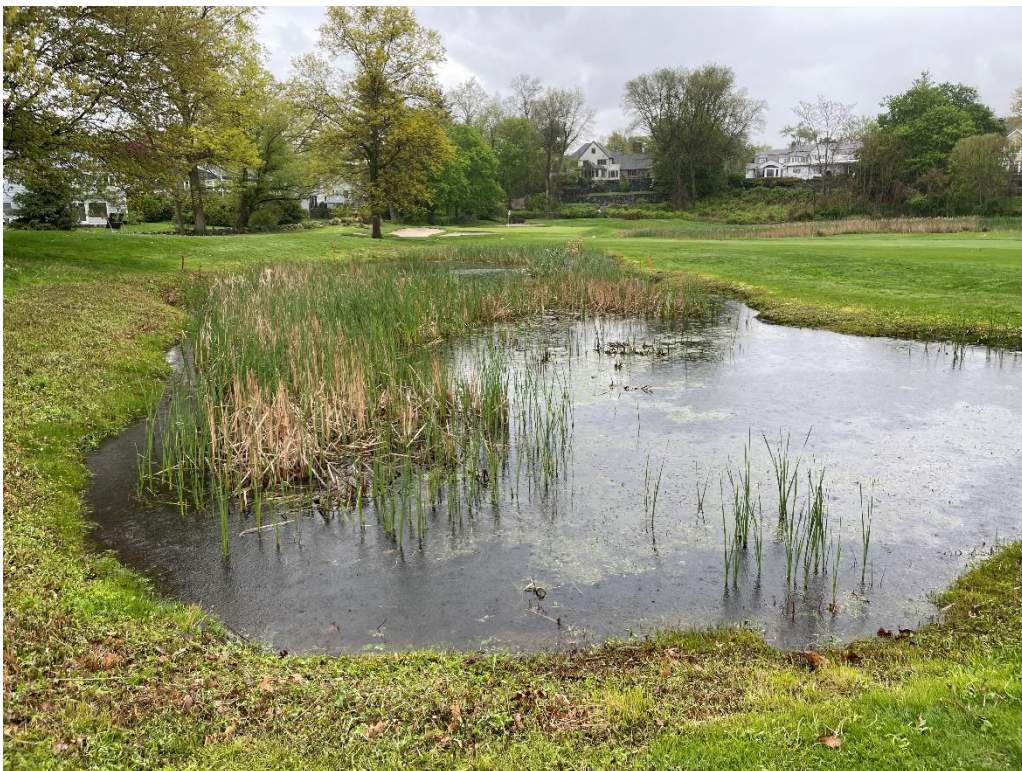
View from the southwest end.

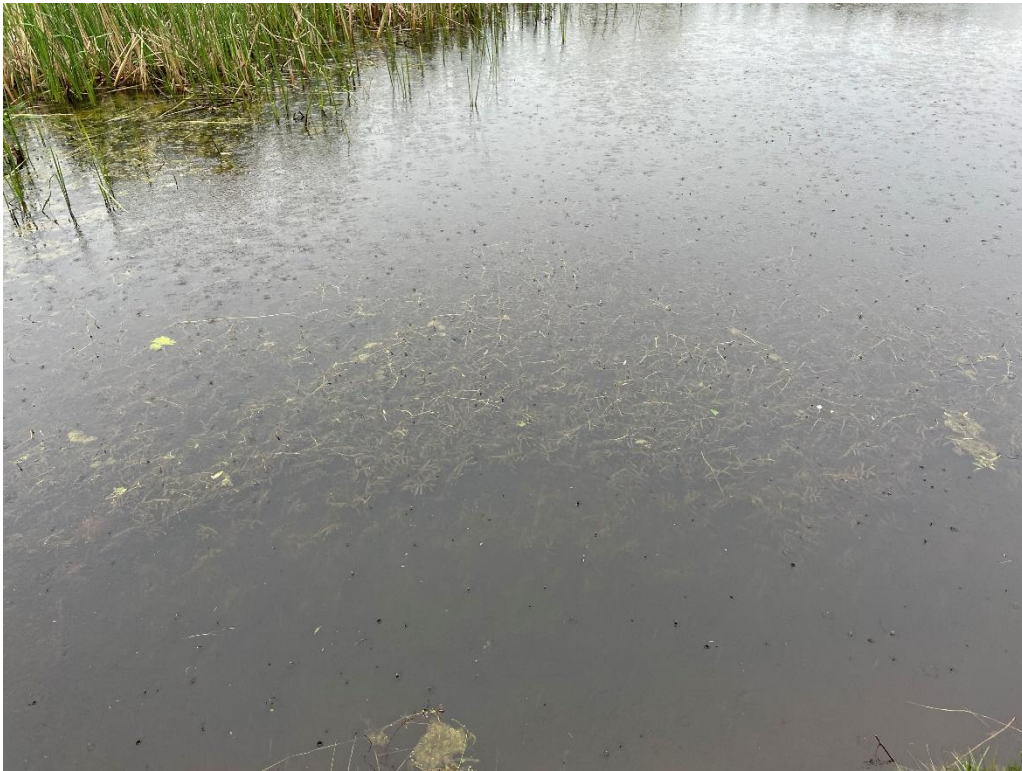
Vegetation observed includes cattail (*Typha sp.*) and pondweed (*Potamogeton sp.*). These plants are obligate hydrophytes. There are areas of this feature which are vegetated and others which are not. Vegetated areas meet the criteria for wetland vegetation.

Pondweed visible below the surface.

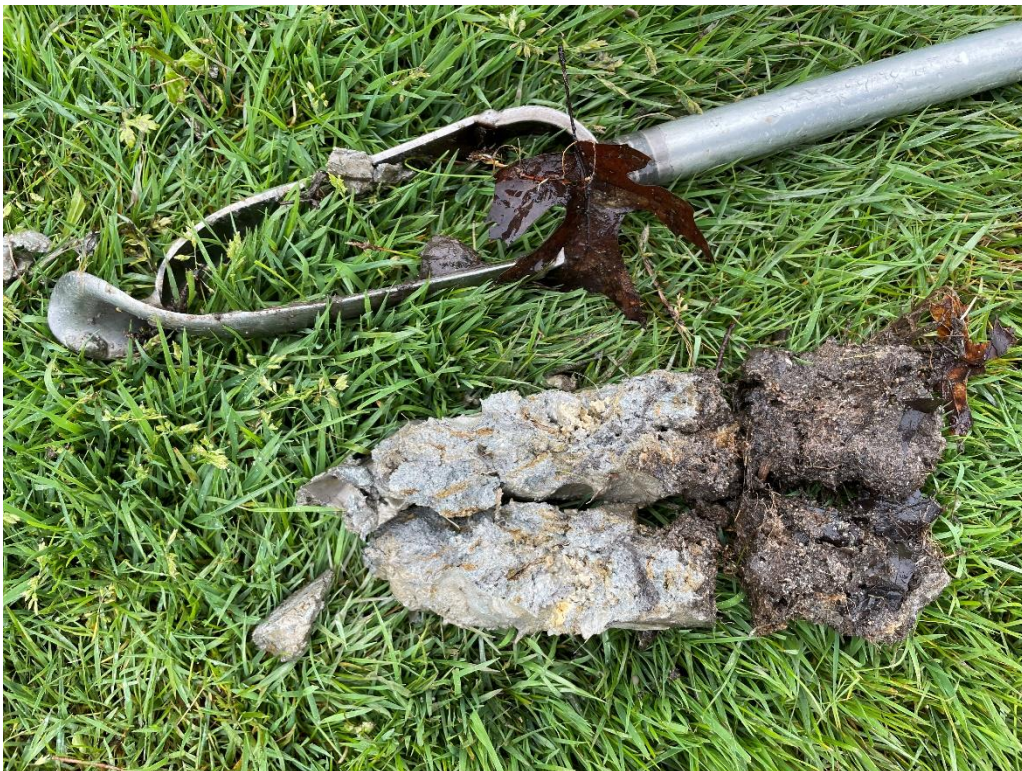
Soil near the edge of the feature generally consist of an approximately two- to six-inch layer of sand and gravel and organic matter. This accumulation may be thicker toward the center of the feature, but that area was not accessible for sampling. Below that is a layer of grey clay (approximately 2.5Y 6/1 in color) with prominent redoximorphic features. This soil exhibits a depleted matrix and is considered hydric.

Typical soils along the shallow edge of the feature. Soils exhibit hydric characteristics. Note first layer is accumulated sand, gravel, and organic matter.
